THE USE OF TIMBER INTO THE TRADITIONAL NEPALESE ARCHITECTURE

Keywords: Timber, truss, roof structure, Nepal, 2015 earthquake

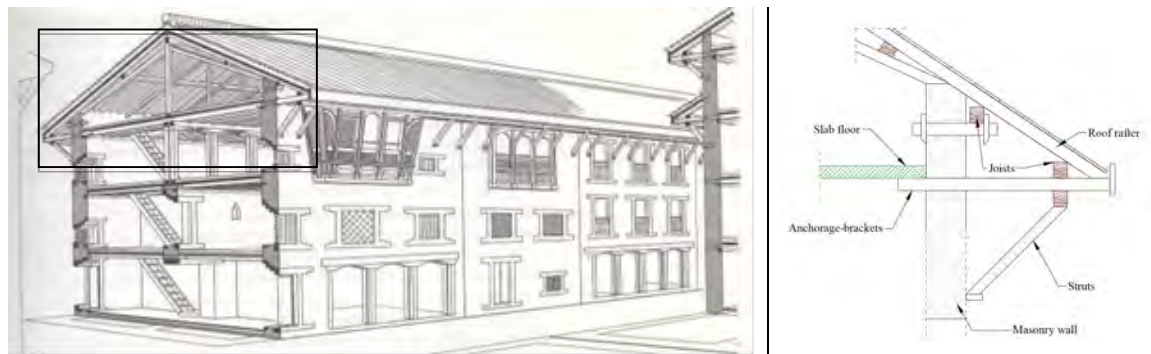
Traditional dwellings are similar in dimensions, but present differences in relation to the availability of materials and the owner's economic condition. The typical house (Fig.1) has a rectangular plant, generally 6 meters in depth, while the length is usually in the range between 4 and 8 meters, although different values can be found in some cases. The main feature is the vertical arrangement of the rooms at different stories, that is, generally, not related to the size of the base. The number of floors range from 2-4.

Figure 1: (left) Axonometric projection showing a typical Newari house [6, p. 37]; (right) detail of the façade (Authors for the purpose of the article, 2019).

1. symmetric plant configuration, which is rectangular for most of the traditional buildings (Fig. 1);

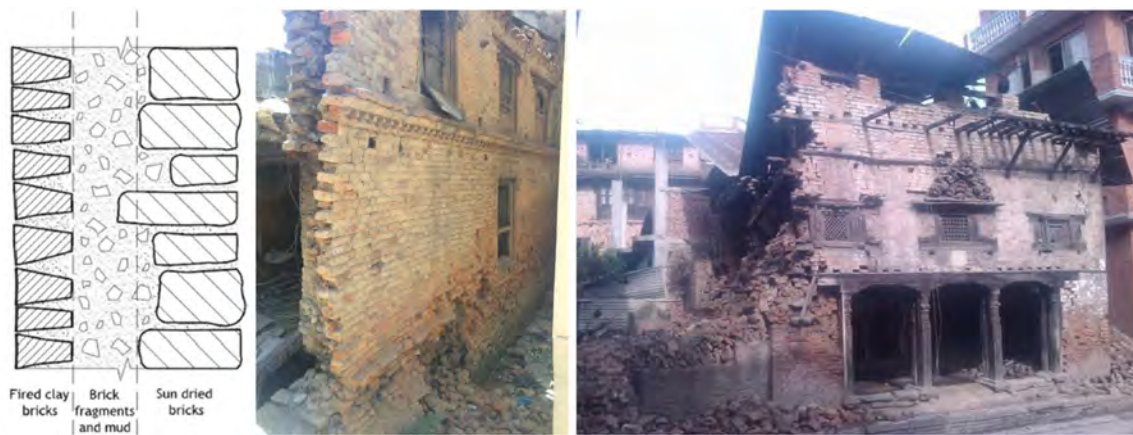
Two main kinds of bricks are used: one on the internal side of masonry, while the other is visible on the external side. Masonry panels are composed of three vertical layers (Fig.2): the external layer is made of *daci appa* bricks where the central core is filled with rubble stones, brick fragments and a mud mortar, on the internal side *ma apa* bricks are disposed. Connection and collaboration of the three masonry layers is not always guaranteed by brick interlocking; low quality mortar, moreover, does not help. The combination of poor quality mortar and lack of maintenance may cause a loss of thickness in the mortar joints, which is amplified by environmental agents; the containing action onto the inner core and, in general, the bearing capacity of the wall panel are thus further reduced. Another common phenomenon is the detachment of a brick layer, caused by both poor material properties and water penetration during monsoon rains. The lack of interlocking between bricks affects the global resistance of the wall and is a major cause of failure during seismic events (Fig. 2).

Figure 2: Masonry details: (left) a sketch of a hypothetical arrangement of layers in the wall thickness (Authors for the purpose of the article, 2019); (central) 2015 Earthquake effects on masonry walls [9 – Bagmati 2015]; (right) 2015 Earthquake effects Baktapur [10 – Baktapur 2015].

The bearing capacity of masonry walls is often compromised by poor transversal connection, through the thickness, between the wall parallel layers; the insertion of diatones or, in general, elements providing connection between the wall external faces, could highly improve the performance of masonry panels.

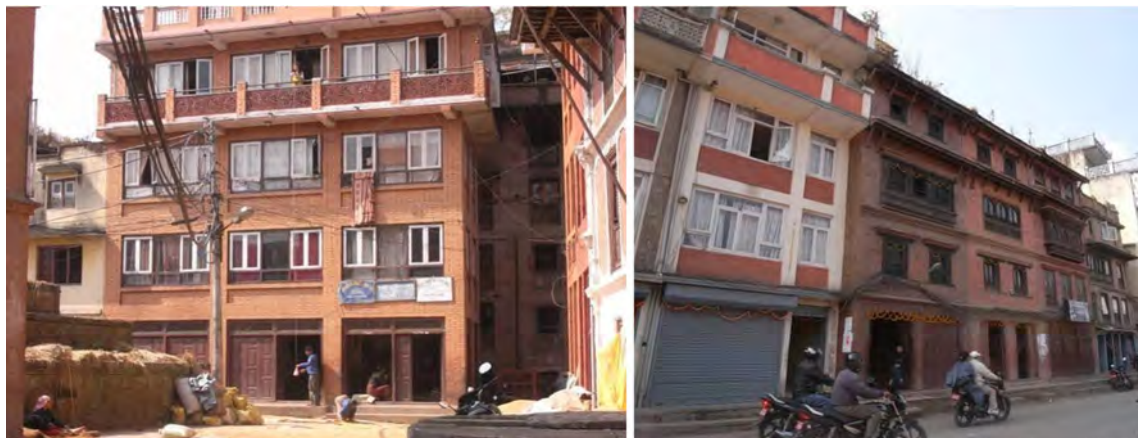
However, since the 19th century, openings have acquired a taller and tighter shape, showing a more vertical orientation. The new style of windows totally modified the external appearance of façades, replacing the presence of a bigger central window with a row of windows (Fig. 4) [6].

Figure 4: (left) a new Newari house in Bhaktapur (S. Tonna, 2011) ; (right) the two Newari types (the traditional and the new one) compared (S. Tonna, 2011).

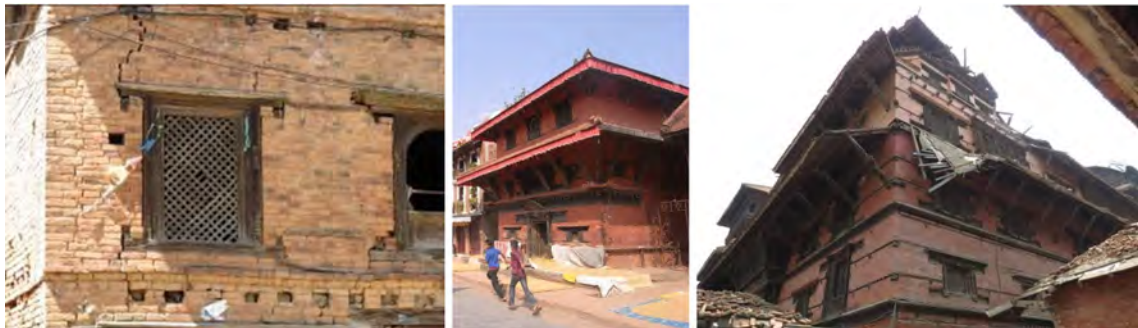
2. reduced length-to-depth ratio (in most cases, 1.5 or less);
3. symmetrical location of small openings (Fig. 1);
4. reduced inter-story height (less than 2.5 m) and limited number of stories (usually up to three);
5. presence of timber bands at floor levels (Fig. 5-right);
6. vertical posts at corners, acting as vertical tensile reinforcement;
7. timber corner stitches (Fig. 5-central);
8. timber pegs (*chokus*);
9. framing of openings using timber elements (Fig. 5-left);
10. use of timber wedges and effective carpentry joints (dovetailing, etc.).

All of the above listed timber elements clearly enhance the earthquake resistant properties of the Newari houses [8]. Carved timber elements, framing door and window openings, reduce vulnerability typically induced by openings; in some cases, they cover entirely the wall thickness, while in other cases they simply run over the edges. Moreover, through the use of timber wedges, carpentry joints provide energy dissipation.

Figure 5: (left) The framed window [9 – Kathmandu 2015]; (center) timber corner stitch element (S. Tonna, 2011 – Baktapur); (right) the timber bands at each floor [9– Kathmandu 2015].
